## **District No. 5 Schoolhouse**

**Underhill, VT**

**Prepared by Eliot Lothrop  
Building Heritage, LLC**

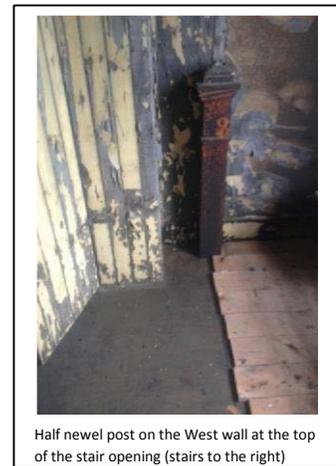
The stairs from the first floor to the second floor had been in the Northwest corner. The newel post at the West end of the stairs against the outside wall is still intact as is the half newel post that is on the North wall which would have been across the top of the stairs from the main newel post which is now missing. All of the railings and balusters have been removed as well and the staircase opening boarded over. Coming up the stairs to the second floor would have brought you into a front foyer approximately 9' deep with hooks on the back wall and a door in the center. To the East of the door is a large 20"x40" chimney set just in front of the wall. Through the doorway there is just one large open room, the chimney with a hole through the wall and many windows along the West and South sides. The interior of the upstairs is sided with tongue and groove boards on the inside of the studs that have been covered up with sheets of Masonite and little strips of wood over the vertical joints.

Half newel post on the West wall at the top of the stair opening (stairs to the right)

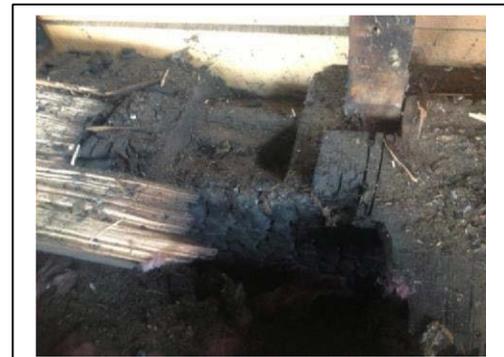
the side of the beam with the lap 2" deep into the beam and 4" tall. On top of the East top plate just to the North of the second floor door, a step lap pocket for a rafter was uncovered. This is an angled notch in the top and back side of the plate so that the rafter is locked into place without any real mechanical connection. The uncovered rafter pocket is directly below one of the existing rafters, which happen to be half round spruce poles (the typical rafter material for a 19<sup>th</sup> century building in this area). The rafters, unpeeled and spaced 3' on center, now sit on top of 9'6" tall 2"x4" stud framed walls. At the peak, the rafters are butted with a vertical plumb cut, most likely nailed together with large square cut nails. All of the rafters appear to be of the same vintage and with a detail at the foot where it now sits on a stud framed wall which looks like it is part of an earlier roof frame.

My guess is that the original rafters are still intact and in their original locations, just set on top of the new stud framed walls. Typically, by the time the second floor was added there would have been a bad rafter or two and the rafter spacing may have been changed when the roof framing was put back together. Having the existing location of the rafter be directly above the original location may have been intentional but it is worth pointing out. Another peculiarity of the roof frame is that it is sheathed with what appears to be the original roof sheathing, still in its original location. One would think that if the roof was stripped, the rafters taken down, and the second floor walls built and roof put back on that there would be larger patches of newer sheathing and that they would be more random. It would not have been unheard of to jack up the entire roof the 10' and build the stick framed walls underneath the elevated roof system.

The charred horizontal timber is the original top plate to the building, now at the second floor level. The notch in the center of the beam is a step lap pocket, in which, the rafter once sat

Because the building is now a platform framed structure, it requires a strong diaphragm at the second floor level in order to keep things from shifting and distorting. In order to accomplish this, the existing 1x4 maple strip flooring that is currently the top layer should be removed carefully for potential re-use. The reciprocally sawn 1" subfloor boards should also be removed as many of them are fire damaged. Once the floor joists have been inspected and repaired or reinforced as needed, a new plywood subfloor should be installed or diagonal boards on top of the joists.

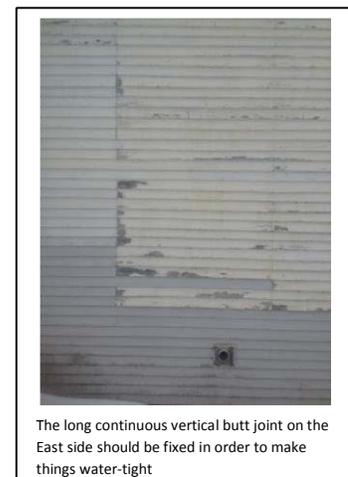
The East side of the building at one point had an annex attached to it. Currently, there are no penetrations through the wall except for the second floor door that is accessed by the long metal staircase that leads up the side of the building. Most of the clapboards on the wall have been replaced with pre-primed spruce which has not been painted since its installation. There is also a smaller amount of slightly earlier spruce replacement clapboard that was not pre-primed but was painted in place. There are a couple areas throughout the wall that should be addressed at some point in order to make sure that things are watertight. For instance, there is a large section in the middle of the wall where there is a common vertical butt joint. The lower sections of the corner trim has been replaced with new pre-primed pine but the cuts made to the original trim boards are a square 90 degree cut instead of a 30 degree bevel as is typical in order to shed water that gets into the joint away from the building. Also troubling is the fact that there is a large amount of charring on the interior of this wall, visible from the second floor inside. This may or may not relate to the cracks in the sheetrock that are visible downstairs. It would be wise to strip a fair amount of the clapboarding and sheathing from the outside in order to thoroughly inspect the framing. It is possible that the sill has moved slightly and is causing the cracking but it would be good to make sure that it isn't a result of insufficient framing in the first floor walls due to the fire that is causing the movement. Any new clapboards should be pre-

The long continuous vertical butt joint on the East side should be fixed in order to make things water-tight

primed quartersawn spruce or clear vertical grain hemlock with the eased edge ripped off on the table saw. Clapboards should be installed on top of 30 pound felt paper. All end cuts should be re-primed, joints staggered and the primed product painted with at least on coat of latex within 180 days of installation.

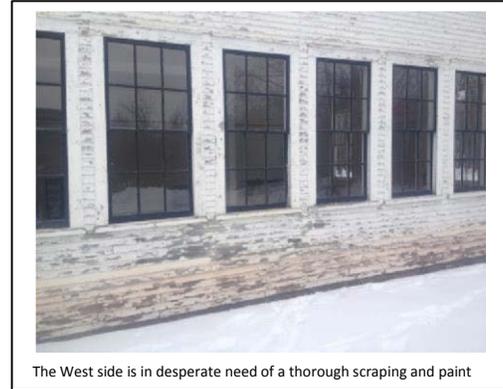
The West side of the building appears to be almost completely intact from the original reconfiguration of the schoolhouse. There are twelve windows total, six on each floor. They are the same six over six large double hungs, 42"x70", seen elsewhere around the building. The paint on the West façade is in very poor condition but most of the clapboards with the exception of the lowest four or five courses still appear to be okay. There will likely be some corner trim repairs needed as well as the clapboards in the lower courses. A thorough scraping and painting of the West side would make a large visual improvement to the barn and will add to the longevity of the wood. The existing paint on the building likely contains lead paint so it is important that a contractor qualified in this work be enlisted and that the EPA guidelines for paint removal are abided by.

The West side is in desperate need of a thorough scraping and paint
