## River Road Speed Study

Municipality:	Town of Underhill
Road Name:	River Road
Location:	Between Maple Ridge and Sandhill Road
Recommended Speed Limit:	<b>40 mph</b>
Evaluation By:	Sai Sarepalli, P.E. Transportation Planning Engineer
<b>Final Report Document Date:</b>	<b>03/30/2016</b>

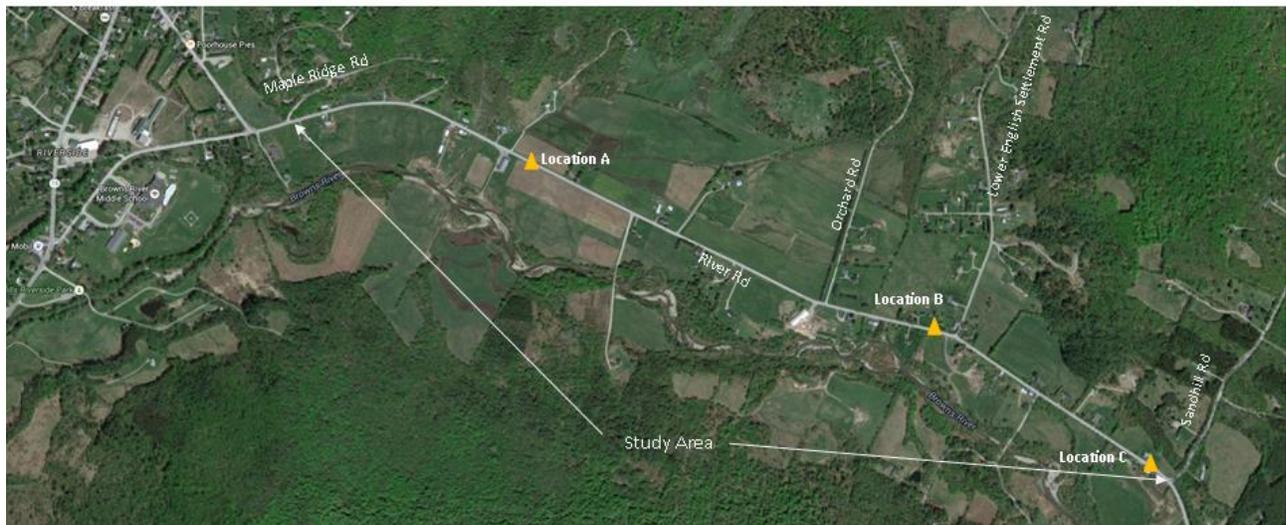
**Figure 1: Study Area and ATR Locations**

River Road is paved and classified by the state as Class II Town Highway and functionally classified as Rural Major Collector. The CCRPC installed 3 Automatic Traffic Recorders (ATR) along River Road at locations shown in Figure 1 to collect traffic volume and speed data. Data were collected from September 9, 2015 to September 16, 2015. The following figure shows the study area and ATR locations.

The 85<sup>th</sup> percentile speed associated with the traffic counts at Locations A, B and C are observed as 48, 46 and 44 mph, respectively, whereas the posted speed limit is 45 mph. This indicates that 85 percent of drivers are comfortable driving at an operating speed between 44 mph and 48 mph or less along the study corridor. This indicates that majority of motorists traveling along River Road are abiding with the posted speed limit.

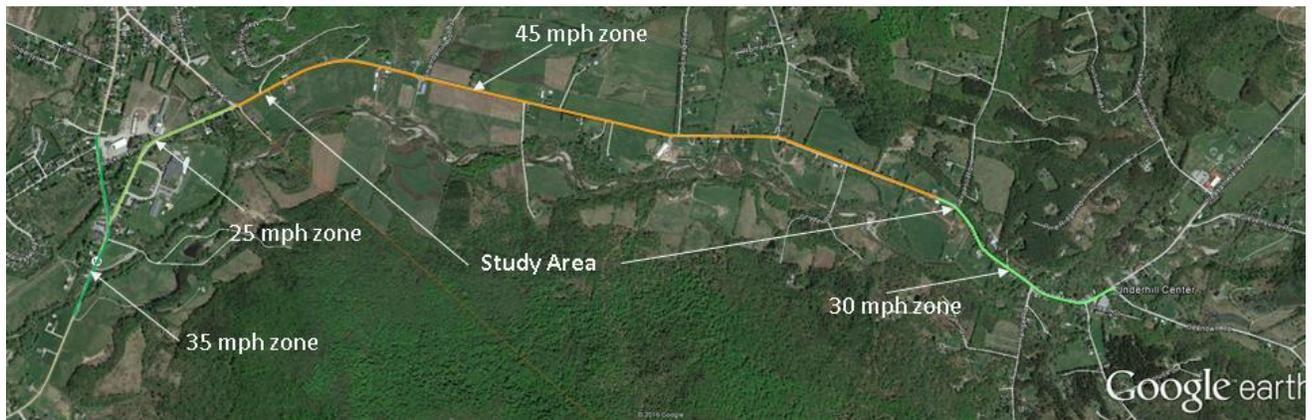
**Figure 2: Posted Speed Limit Zones along River Road**

The following figure shows currently posted speed limit zones along River Road to understand speed zone variations between VT 15 and Underhill Center.

River Road along the study area is fairly a straight section with wide curves (see pictures in Appendix A). As per the observed bidirectional 85<sup>th</sup> percentile speed data, majority of drivers are respecting the posted speed limit. As shown in Figure 2, the posted speed changes from 25 mph to 45 mph for eastbound drivers at the Jericho and Underhill town line and drops to 30 mph at the Sandhill Road intersection. There is a lack of transition zone between the lower and higher speed limit zones. A speed transition zone warns drivers that the roadway environment is changing and that their speed should change as well.

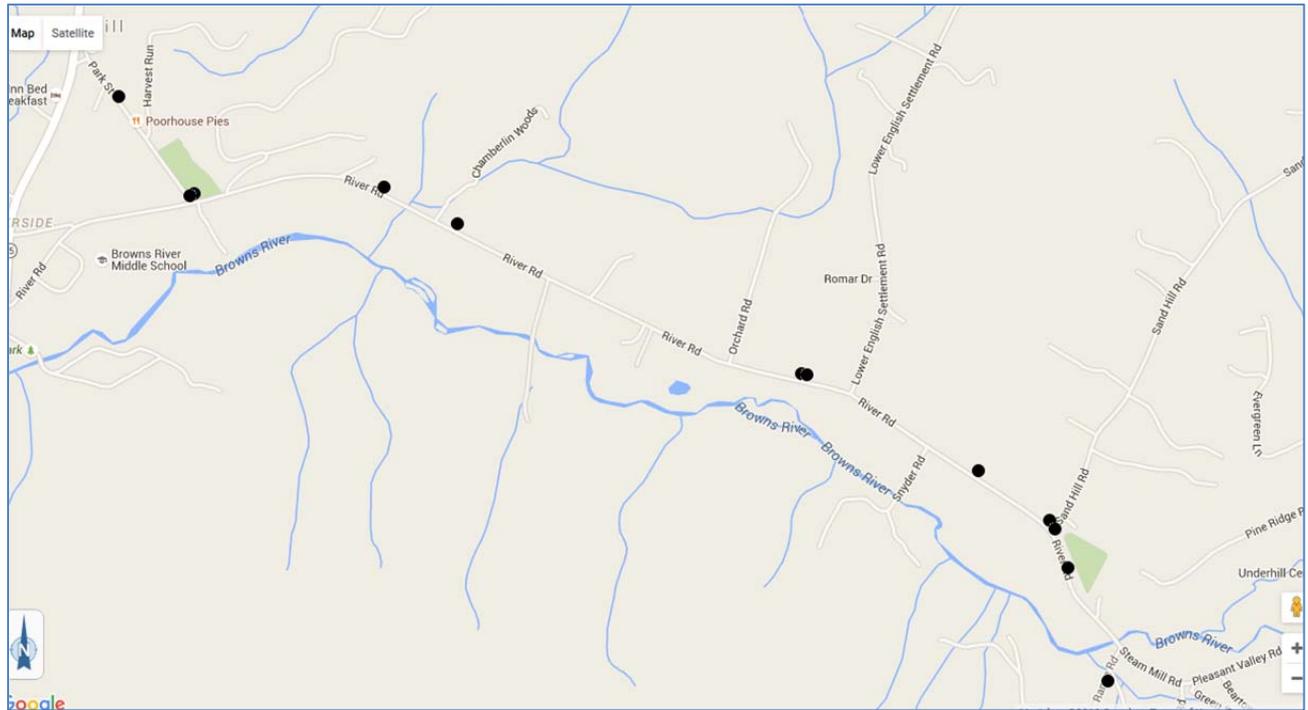
**Figure 3: Historical Crash Locations along River Road**

There were a total of 10 crashes reported between 2010 and 2014 along River Road between Maple Ridge Road and Sandhill Road. The following figure shows historical crash locations along the study corridor.

It is evident from the above figure that most crashes were occurred at intersections along River Road. The following table shows a summary of contributing circumstances for crashes along the study corridor.

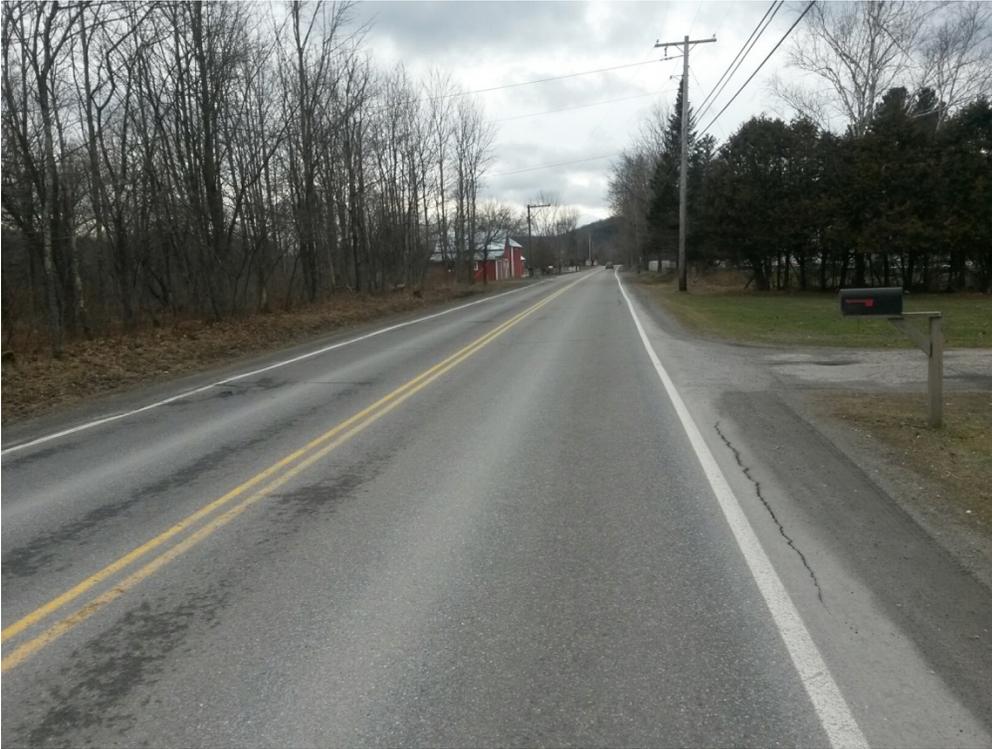
River Road with narrow shoulders, utility poles, mail boxes looking west

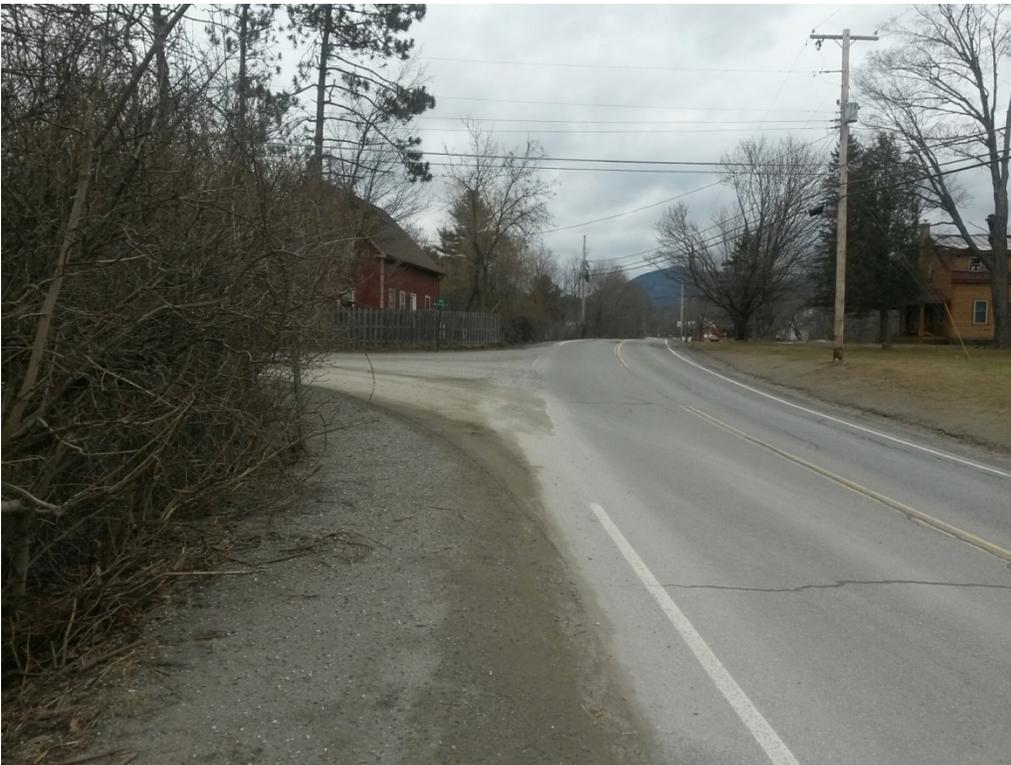
River Road at Lower English Settlement Road looking east

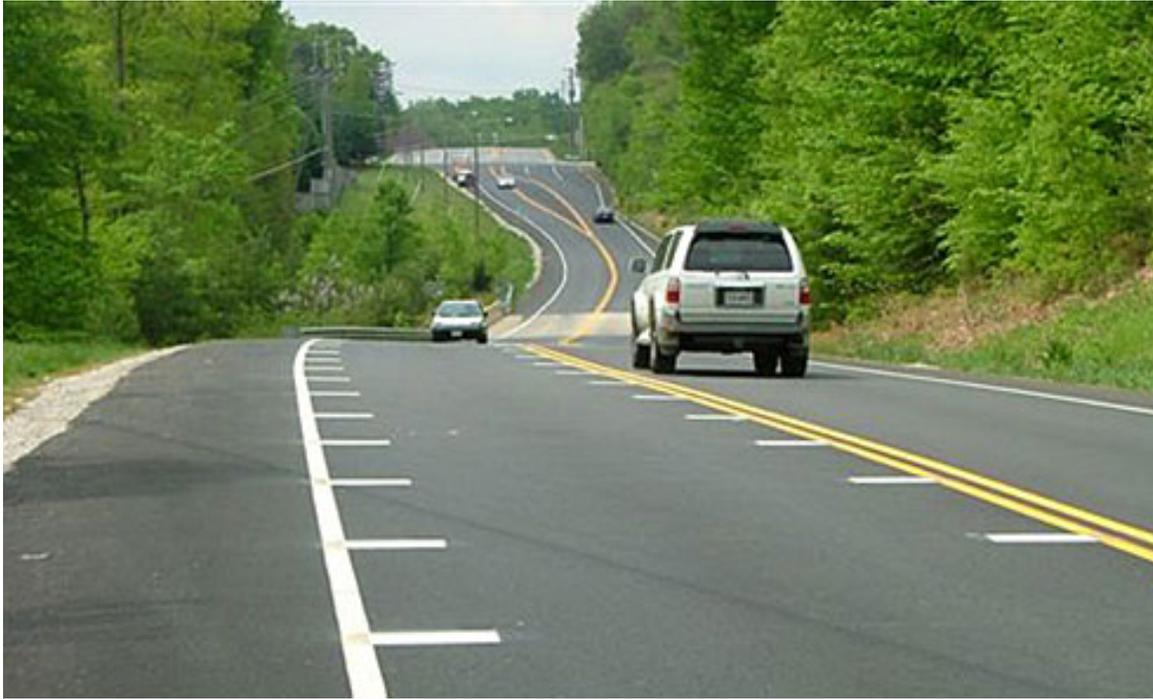
Sample of Optical Speed Bars

It is recommended the Town should consider implementing traffic calming measures such as speed feedback radar signs on poles and/or optical speed bars at appropriate locations to warn and slow motorists traveling on River Road. Optical speed bars are a series of white rectangular pavement markings typically 1 foot wide placed just inside both edges of the lane and spaced progressively closer to create an illusion of traveling faster as well as the impression of narrower lane. See picture in Appendix B.

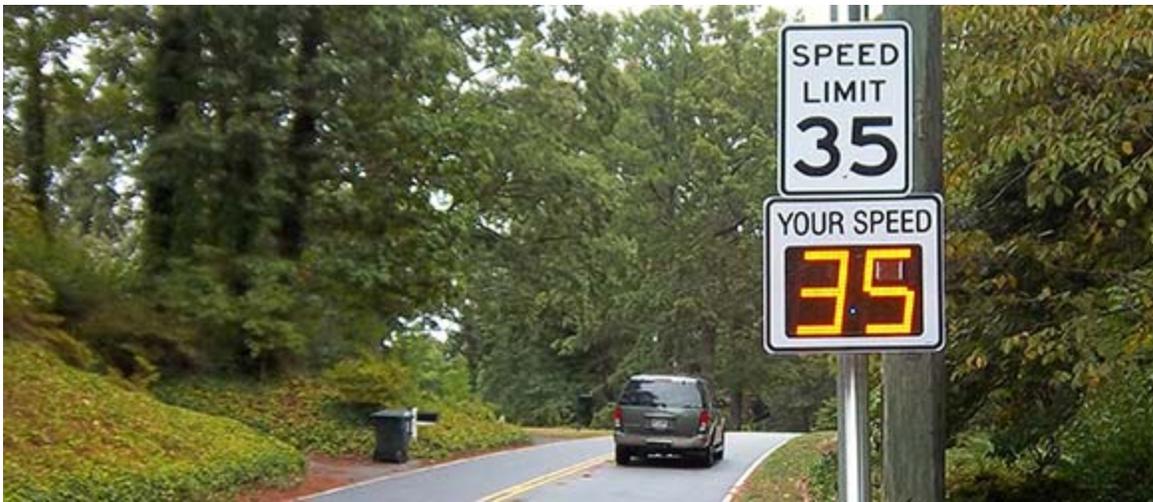
Sample of Speed Feedback Radar Sign
